**Experimental Observations for Determining
the Maximum Torque Values to Apply
to Composite Components Mechanically
Joined With Fasteners
(MSFC Center Director's Discretionary Fund Final Report,
Project No. 03–13)**

February 2006

TECHNICAL MEMORANDUM

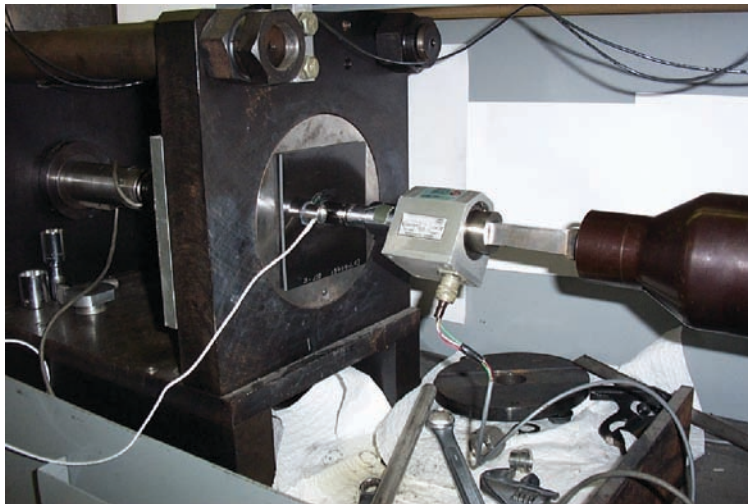
Figure 1. Torque versus tension test.

Testing consisted of installing a fastener in a specimen (table 1), placing the AE transducer on the test specimen, and tightening the fastener until either the fastener reached its maximum tension allowable or the composite specimen failed. Figure 1 shows a test specimen in the torque versus tension tester at MSFC. Figure 2 is a graphic model of the torque versus tension test machine and identifies its major components. Figures 3 and 4 are a top view and a cross-sectional view of the torque versus tension machine, respectively. Figure 5 is a detailed view of the typical test setup. Figure 6 identifies the specific components of the test setup. The bolt head is retained in a specialized fixture attached to the load cell of the torque versus tension tester. The test specimen is positioned on a stationary reaction plate with the shank of the bolt protruding through the stationary reaction plate and the test specimen. A nut retains the test specimen to the stationary reaction plate. For this initial testing, the torque versus tension machine's standard reaction plate was used. The reaction plate provides a mounting area for the test specimen and provides the reaction to the torque-induced compressive bolt load. The reaction plate has an approximately 2-in diameter hole in the center. An adjustable torque transducer provides the tightening operation by turning the nut. The torque versus tension tester records the bolt tension and the corresponding torque produced during the tightening sequence.
